Technical Memorandum

To: Mr. Gary Rayburn, Chair, Healthy Pine River
From: Steve Crider and Christene Jones
Subject: Sediment Survey, Pine River Mill Pond, Alma, MI
Date: September 28, 2016
Project: 22291008.00
c: David Hibbs

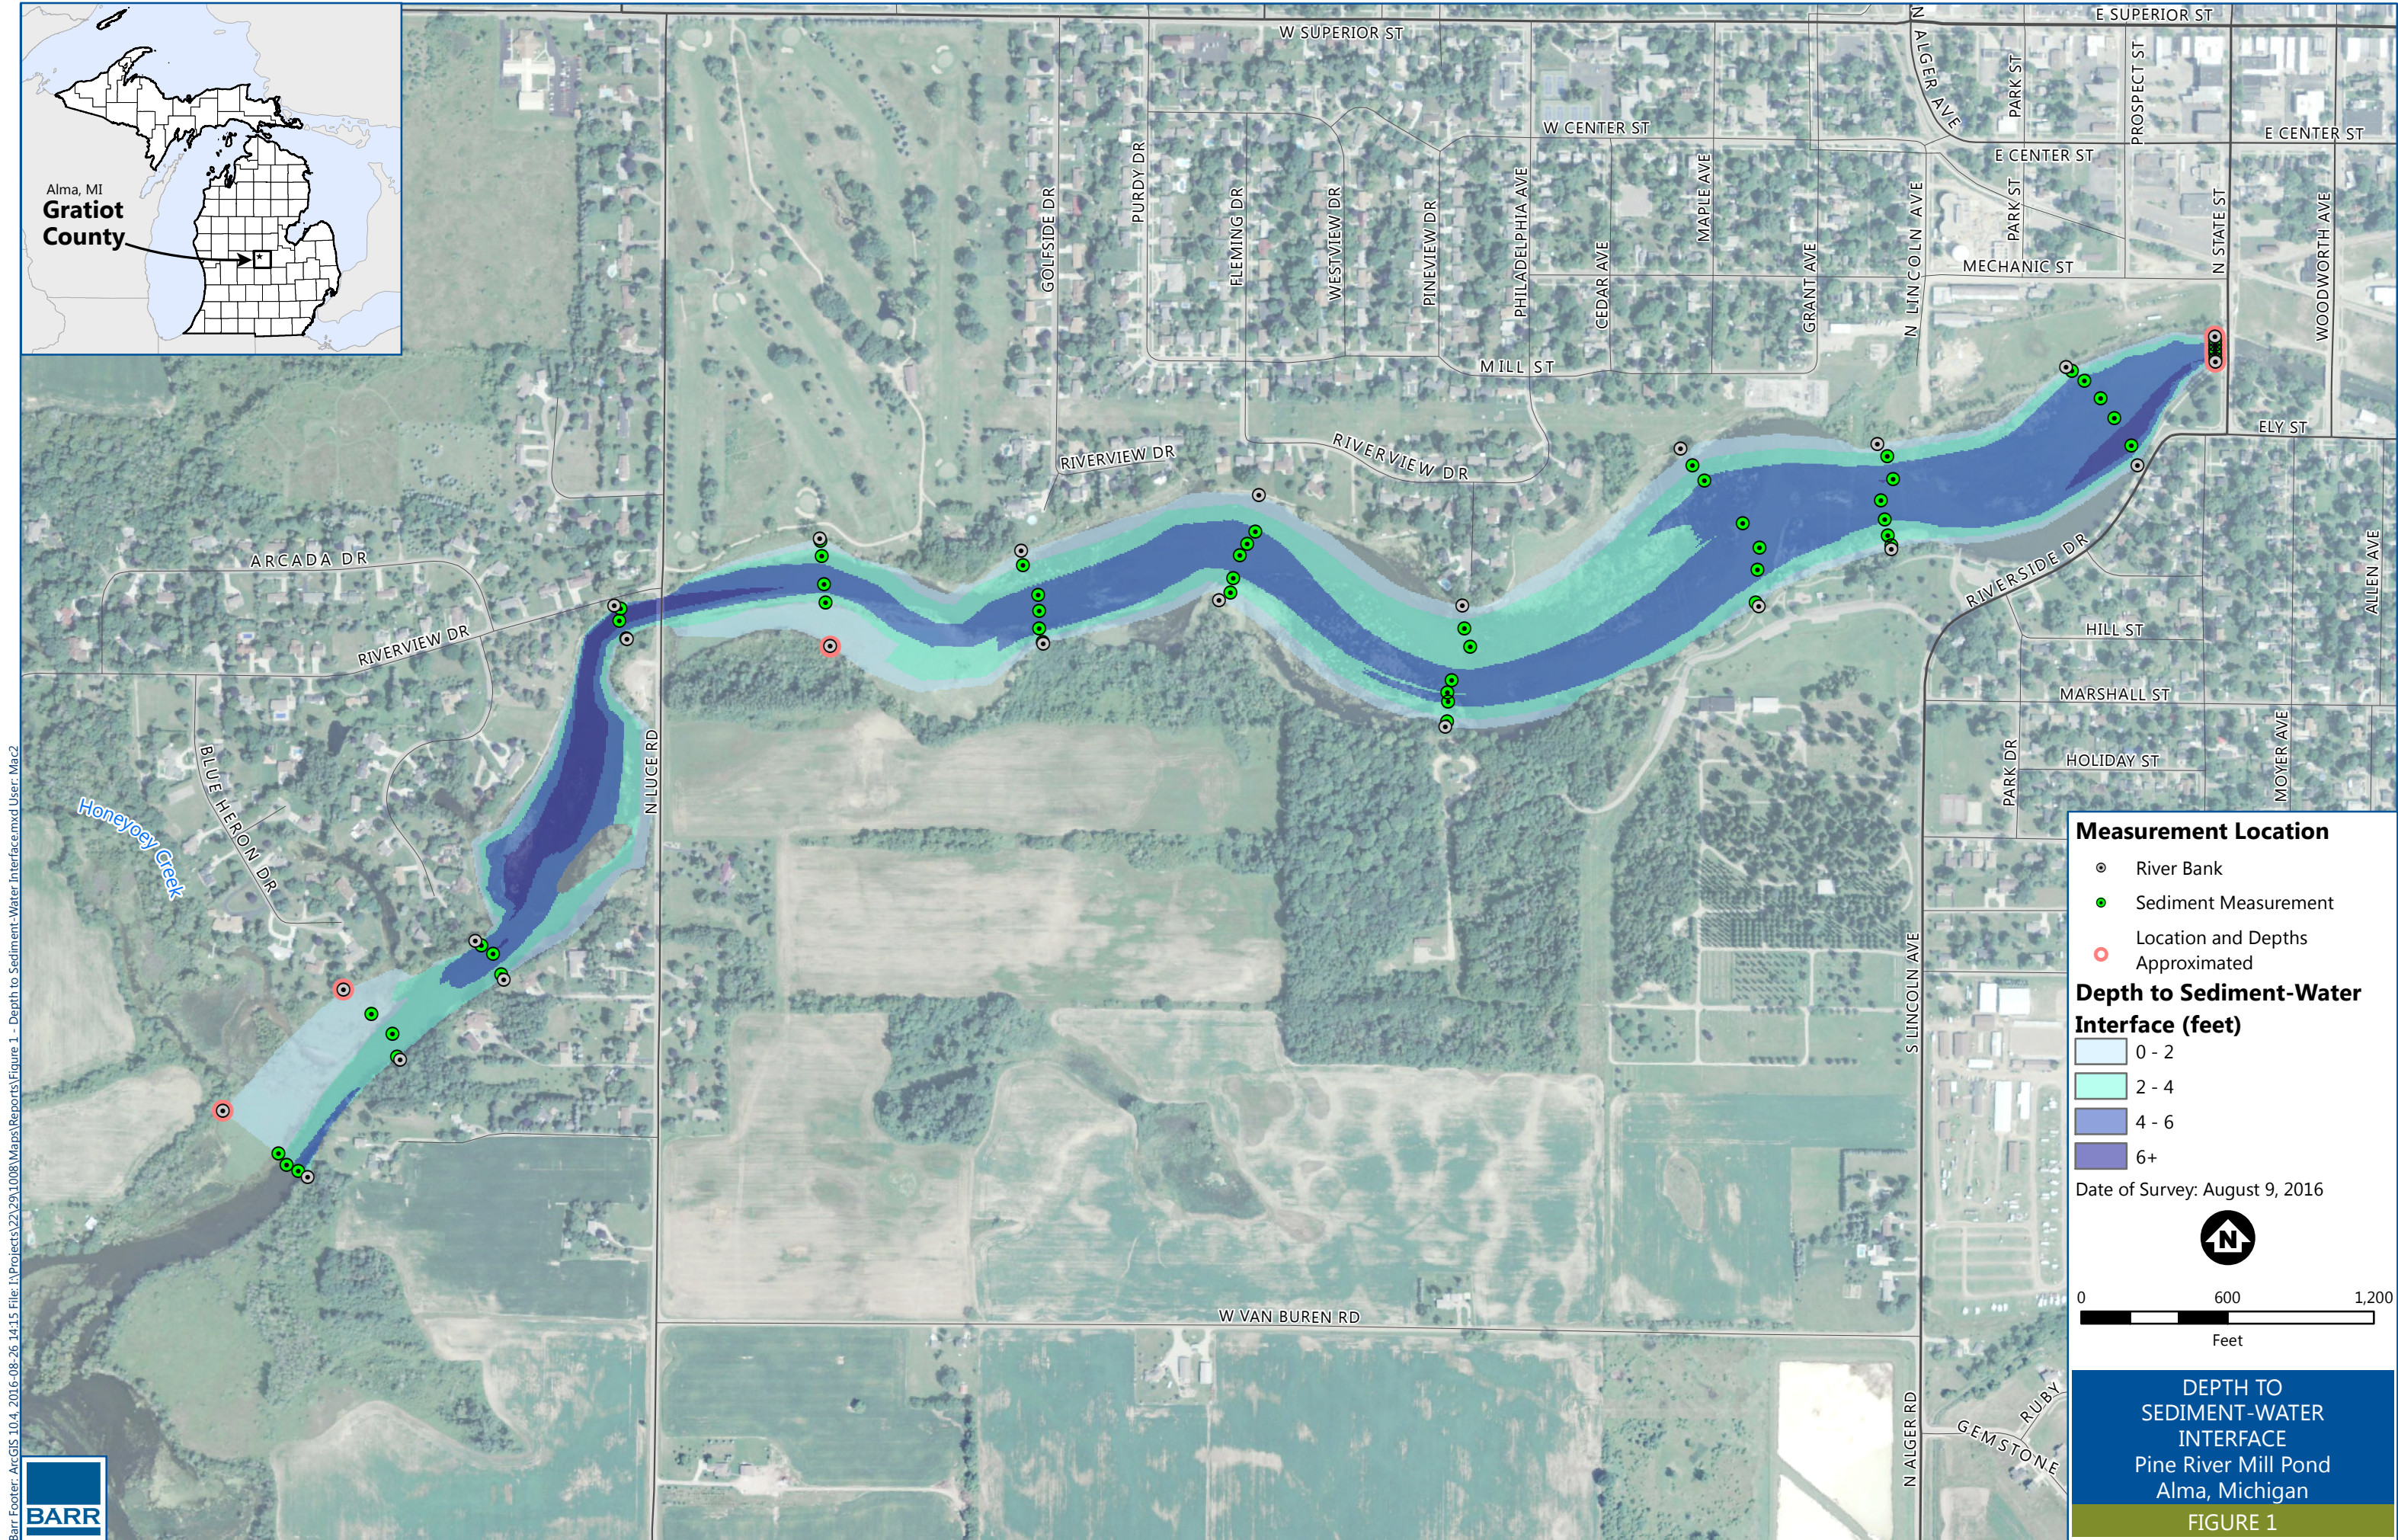
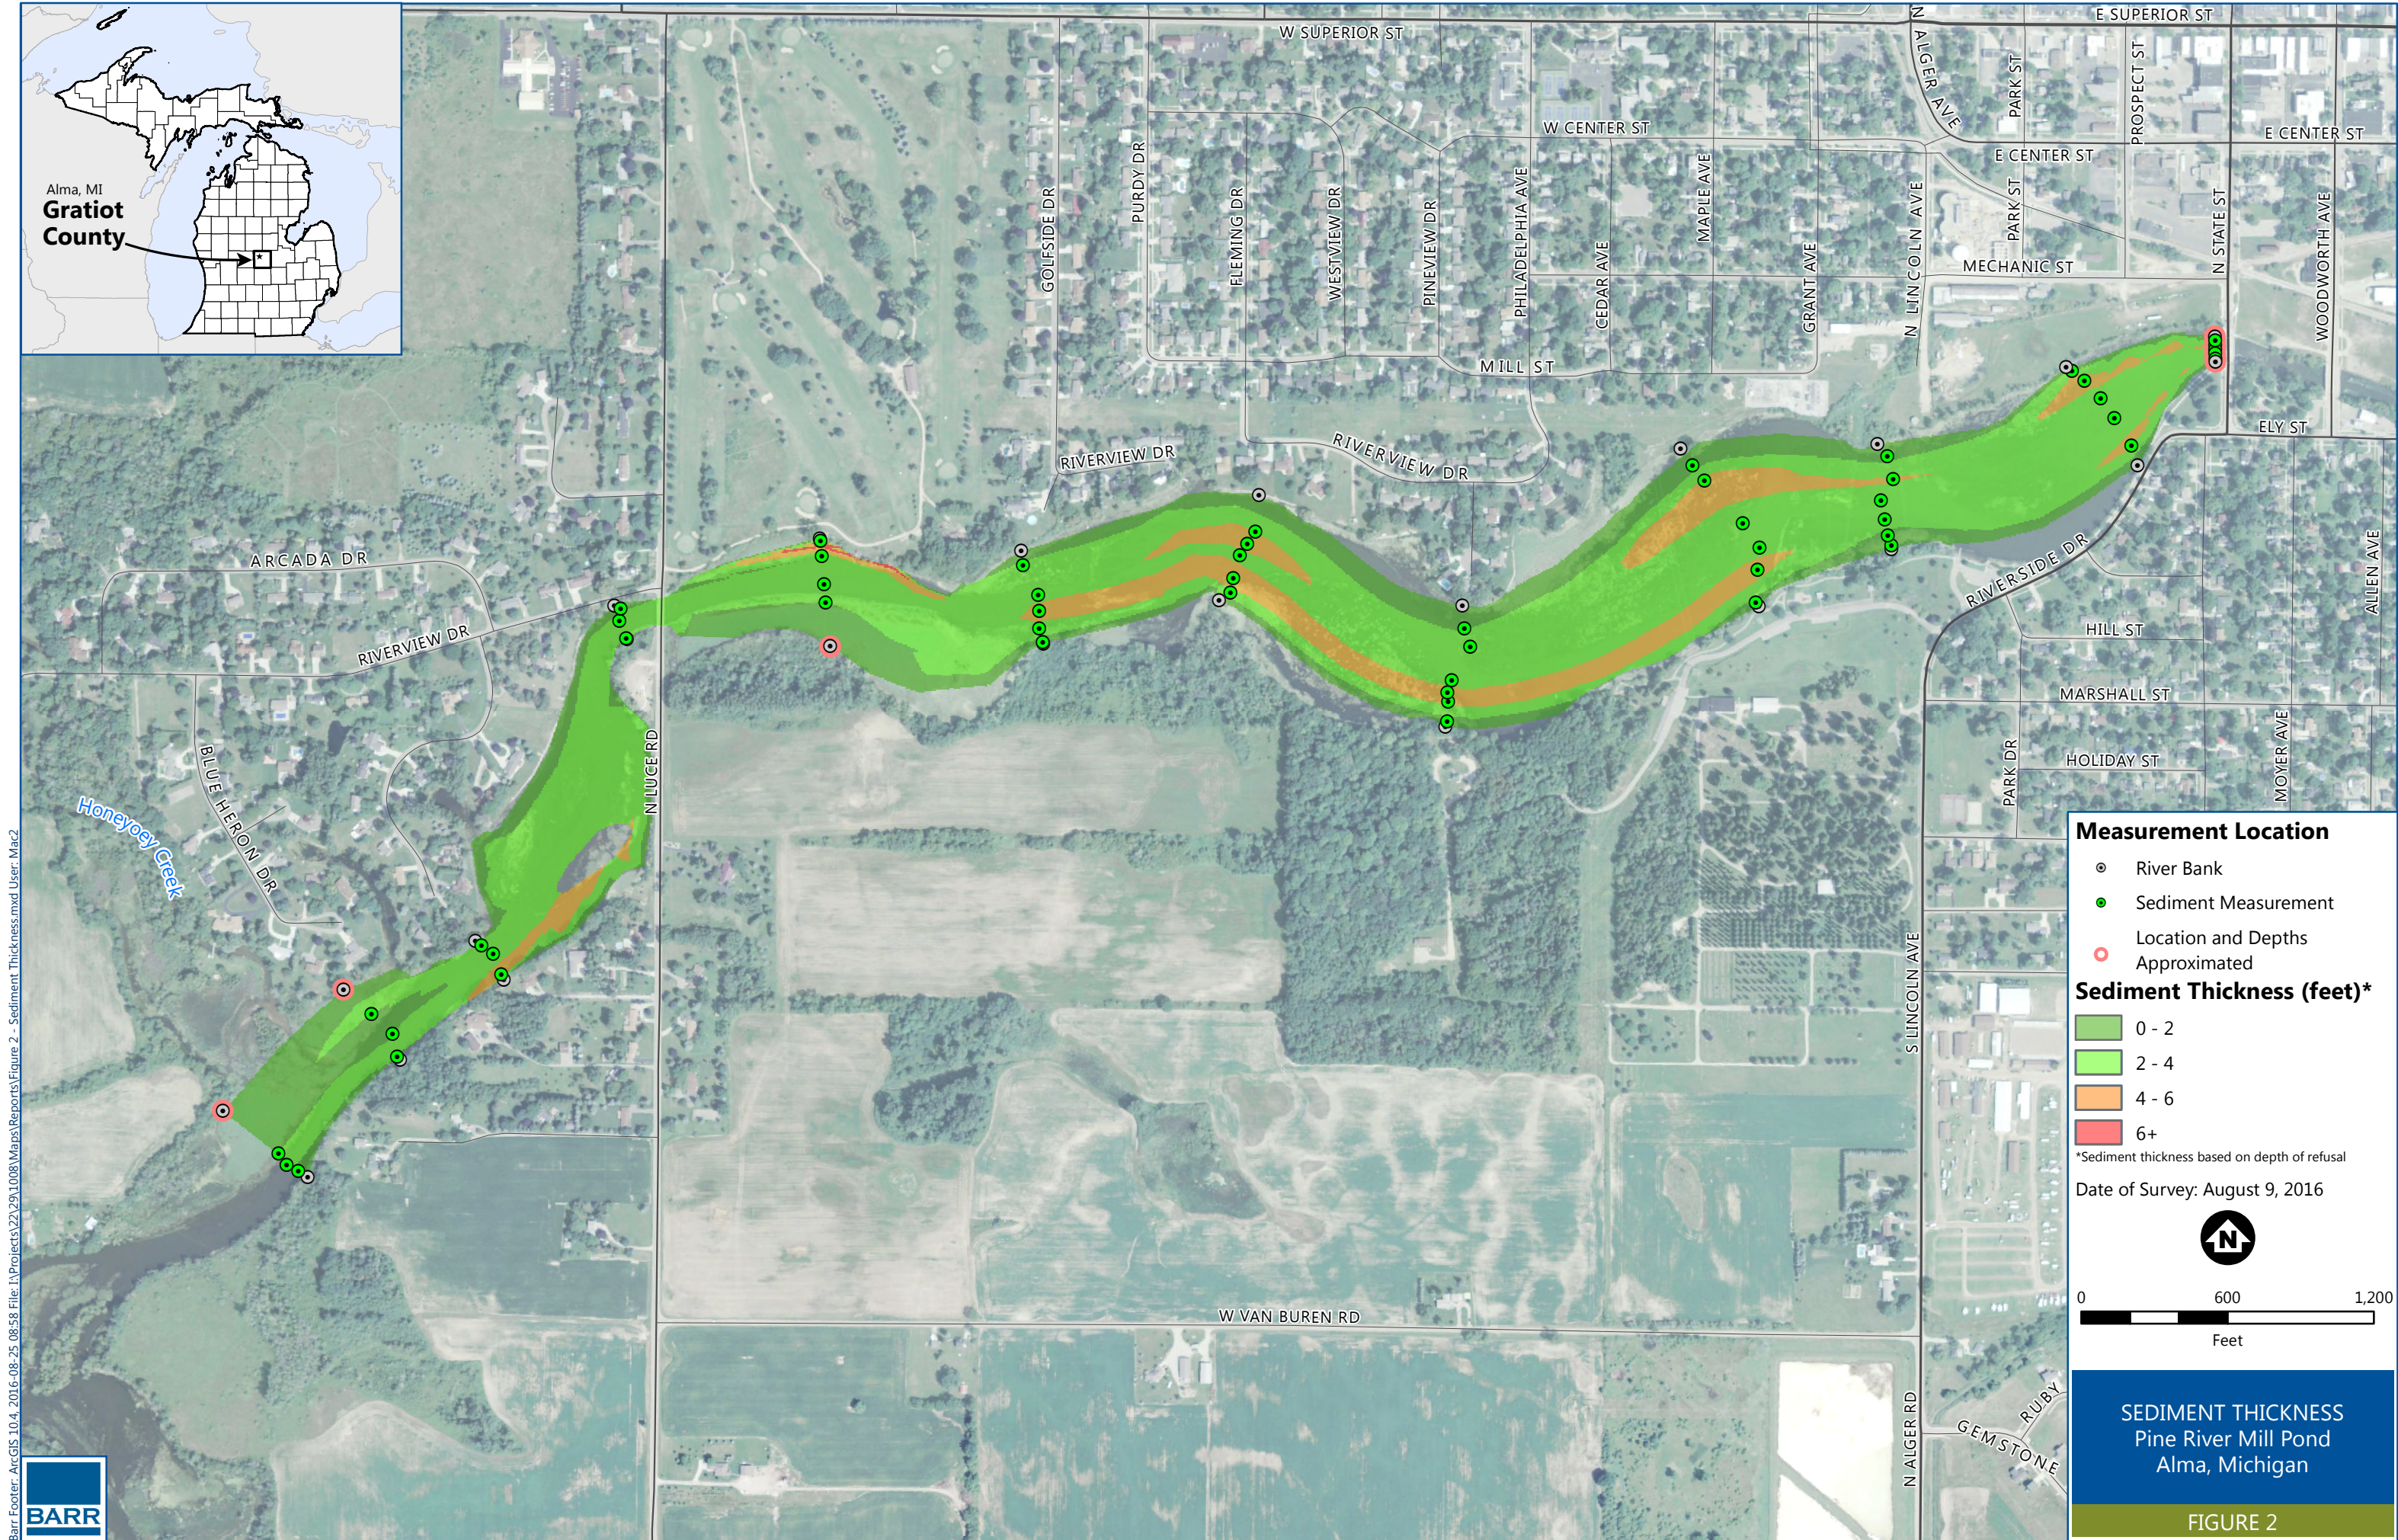
DEPTH TO SEDIMENT-WATER INTERFACE
Pine River Mill Pond
Alma, Michigan
FIGURE 1

To estimate sediment thickness and distribution, Barr performed a series of soundings at 11 transects extending from the dam to just upstream of Honeyoey Creek (see Figure 1 for locations of transects). At each sounding, Barr completed two measurements: 1) the depth from the water surface to the sediment-water interface; and 2) the depth from the water surface to the bottom of accumulated sediments. These measurements were collected from a boat or via wading using a 15-foot long rod of half-inch diameter rebar. However, access to the river's edge was not possible along some transects due to extensive areas of vegetation and lack of clearance for the boat to navigate to shore. The sediment-water interface was measured where the rebar initially came to rest on top of sediment, while the bottom of accumulated sediments was identified by pushing the rebar down from the point of initial resistance until hitting refusal. It should be noted that the refusal may indicate the natural (or hard packed) ground beneath the sediment or debris such as logs buried in the sediment.

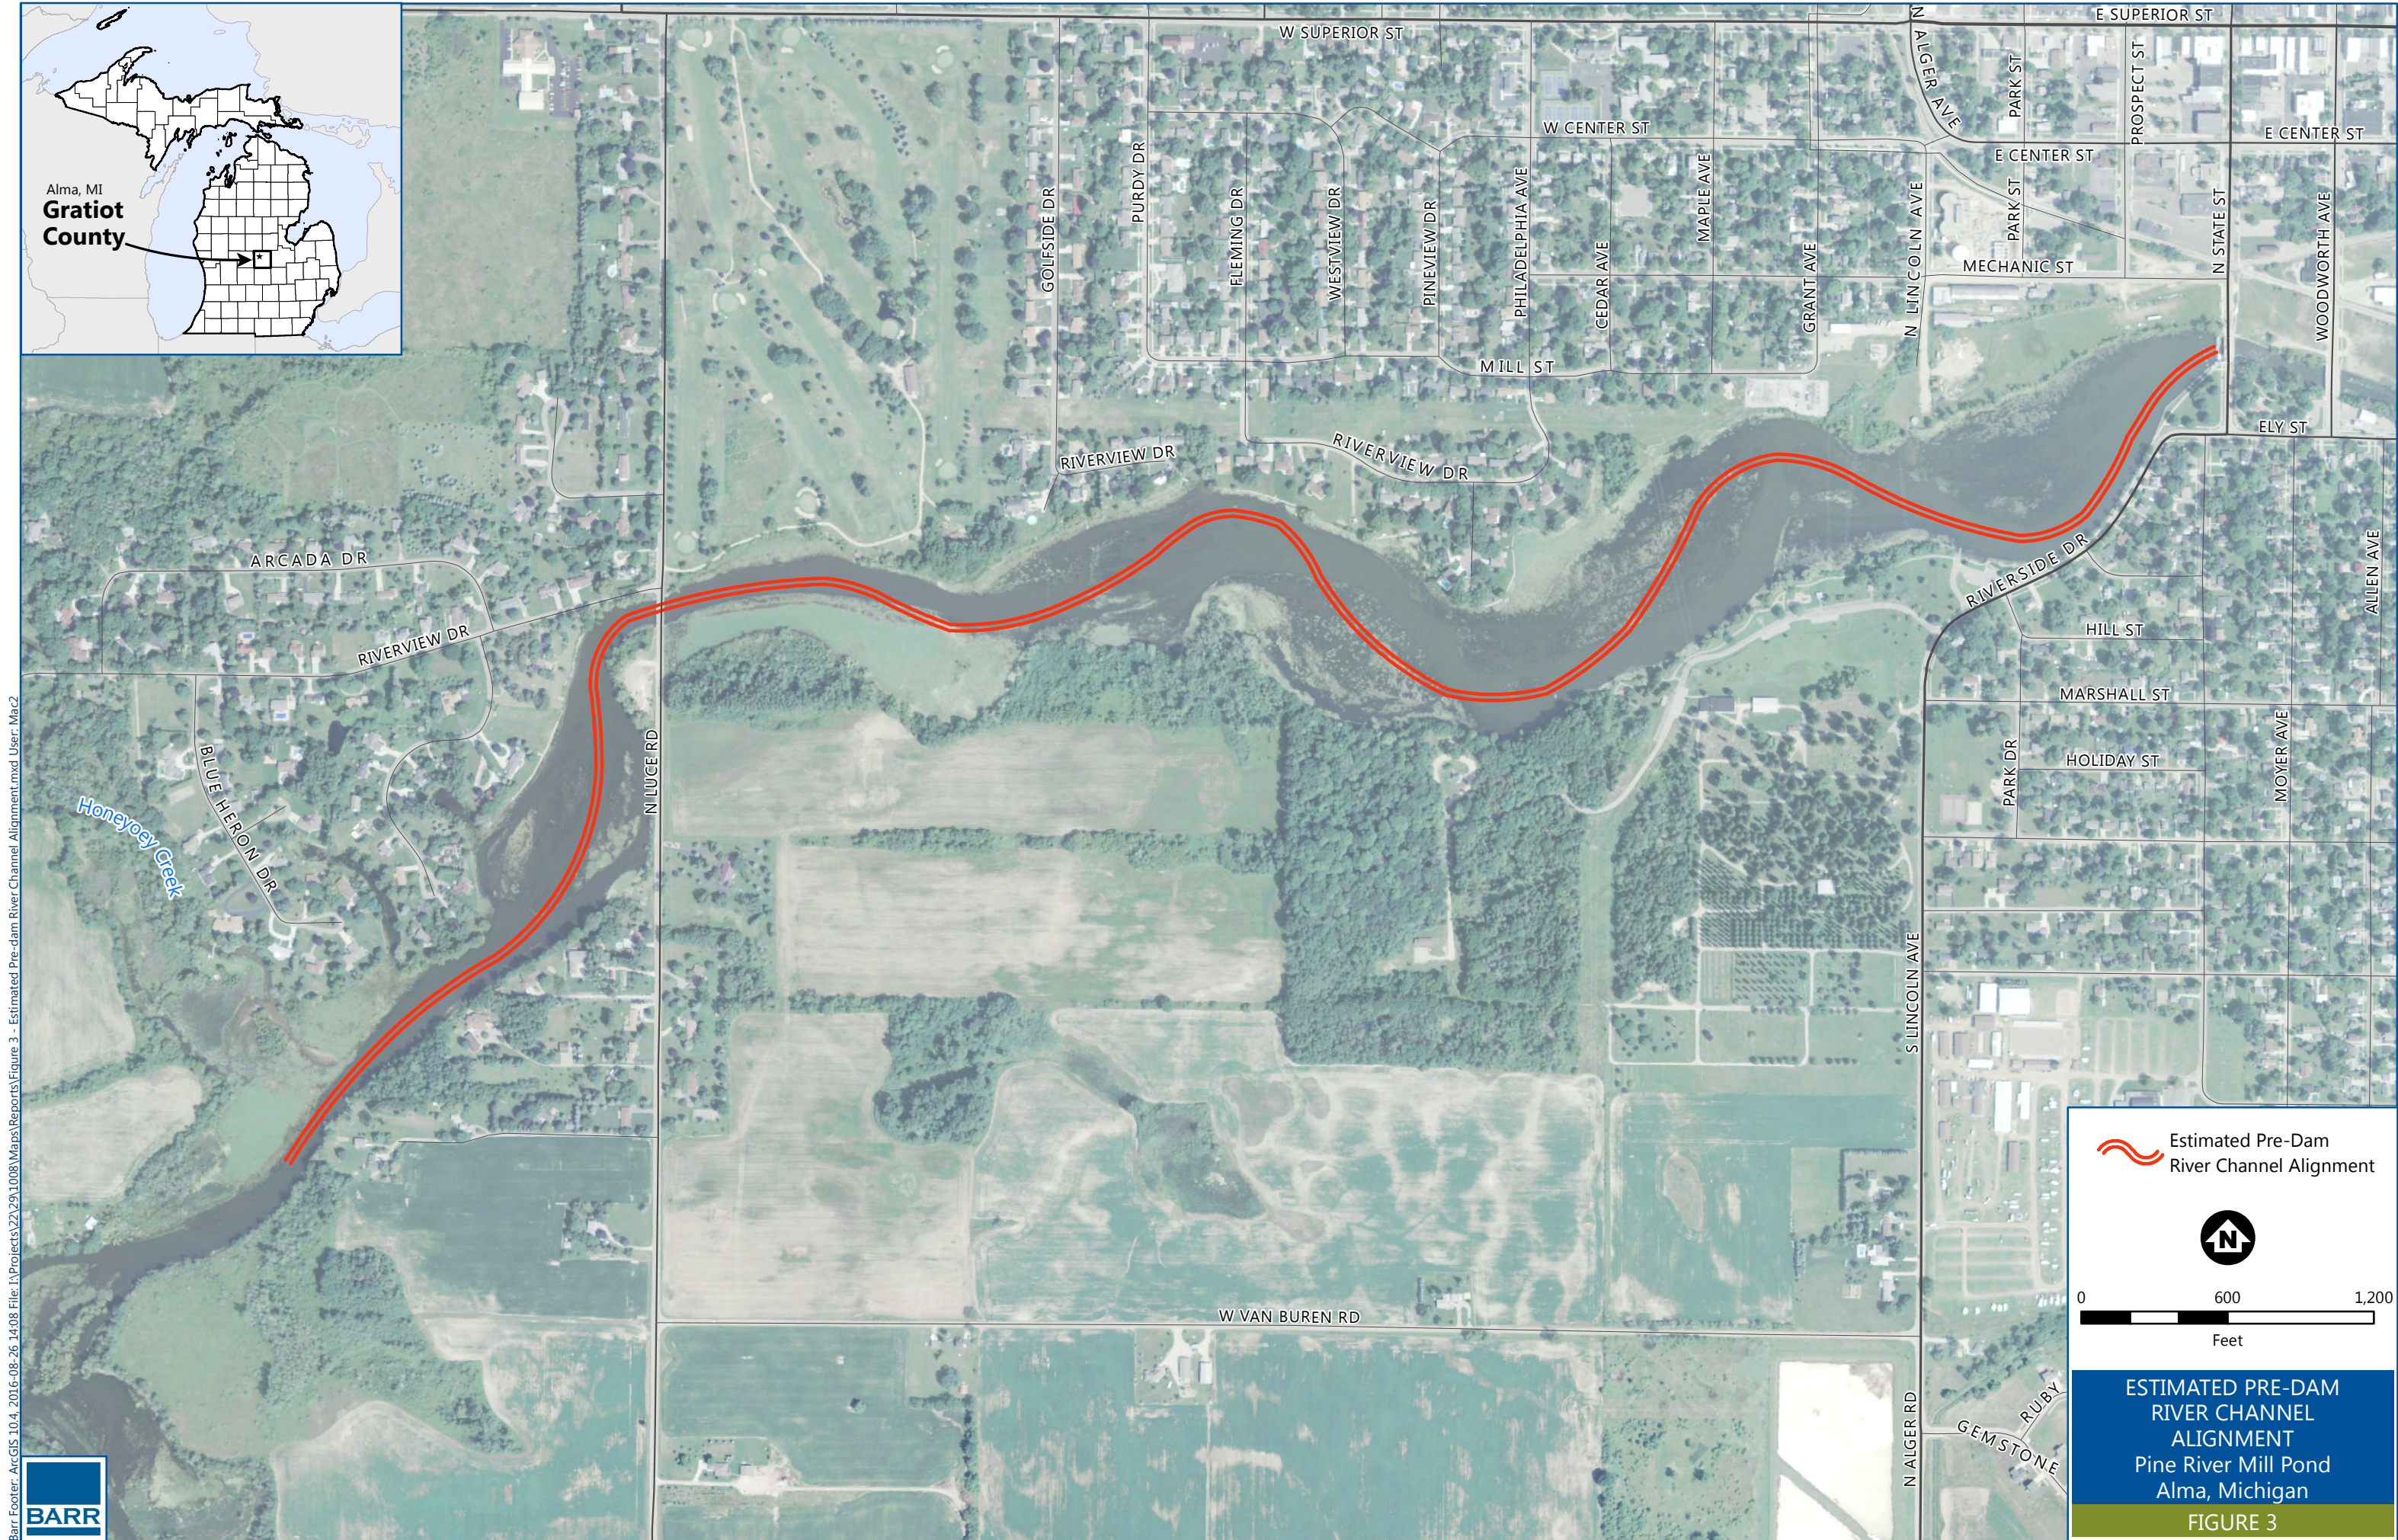
FIGURE 2

Volumetric calculations show that there are roughly 420,000 cubic yards of sediment deposited in the pond. Barr estimated the location of the pre-dam channel by reviewing the depth of channel, the thickness of sediments, and the sinuosity of the river upstream and downstream of the project area. Figure 1 shows the water depth of the pond and the locations of the soundings; the water is notably shallow (less than 2 feet deep) at the outlet of Honeyoey Creek. Figure 2 shows the sediment thickness throughout the pond. Figure 3 depicts Barr's estimate of the pre-dam river channel alignment. If dredging the sediments are part of Healthy Pine River's future project plans, then the sediments will need to be characterized.
